## INTRODUCTION

Wyre Archaeology was invited by Broughton Parish Council to investigate the origins of the local pinfold as part of a refurbishment programme funded through the Lottery Heritage Fund.

The 'Broughton Pinfold' is located on the eastern side of A6 Garstang Road approximately 300m south of the Broughton Crossroads.

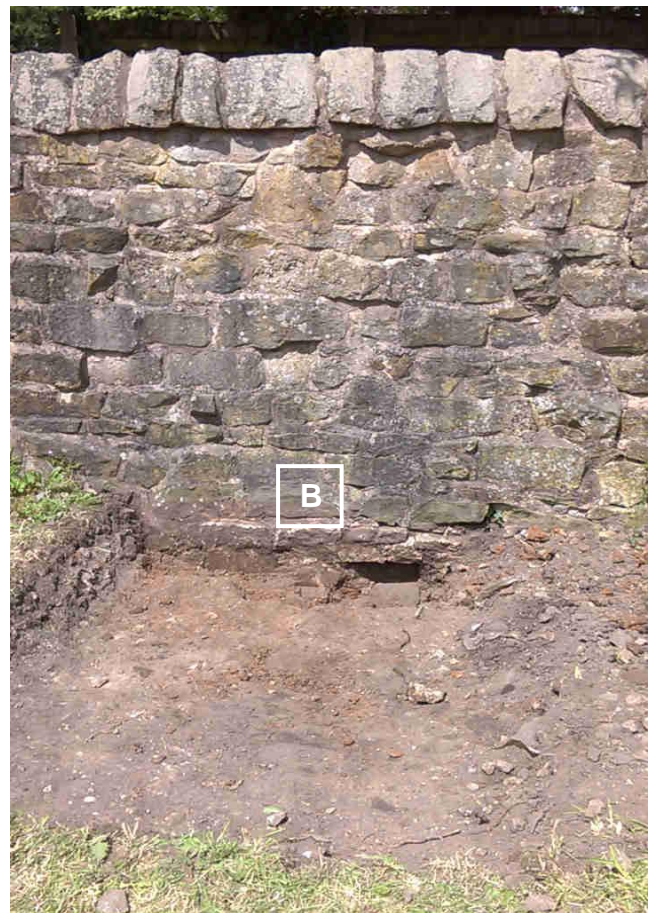
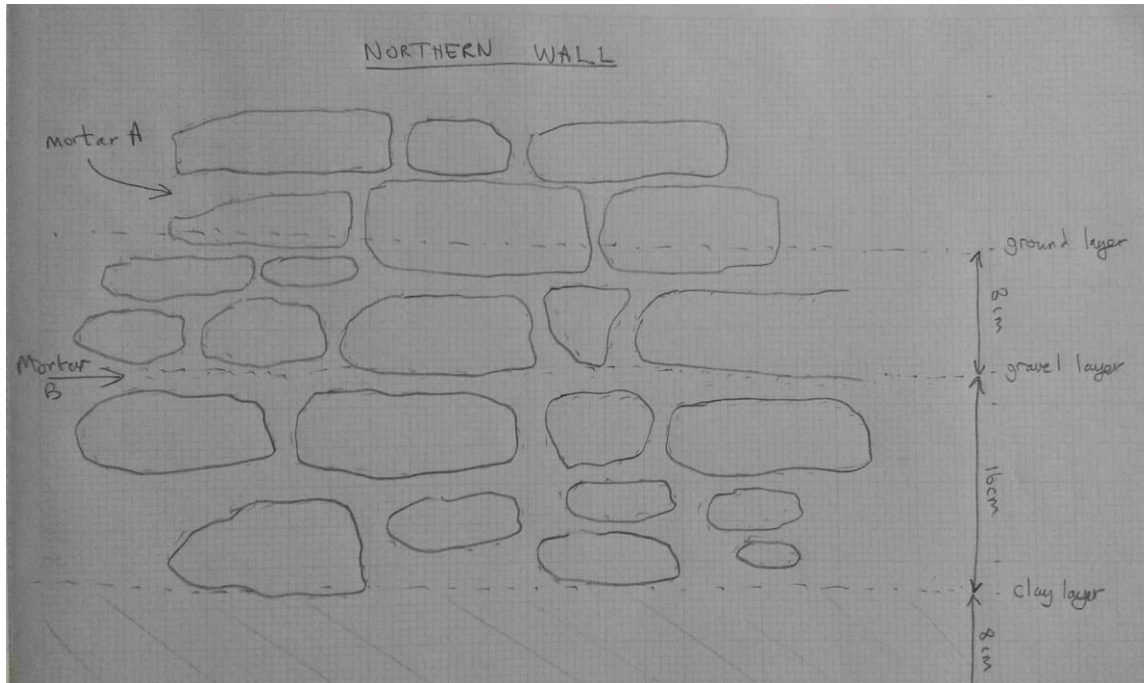
At some, comparatively recent date (probably 1985) the stone structure had been stabilized with concrete pointing. By going closer to the wall and looking at the foundations, the earliest, bonding structure could be discovered. At around 24cm the foundation cut appeared. This was followed down to the base of the wall at around 32cm. The lower two stones (under the normal surface layer) were also bonded with an earlier and different mortar.

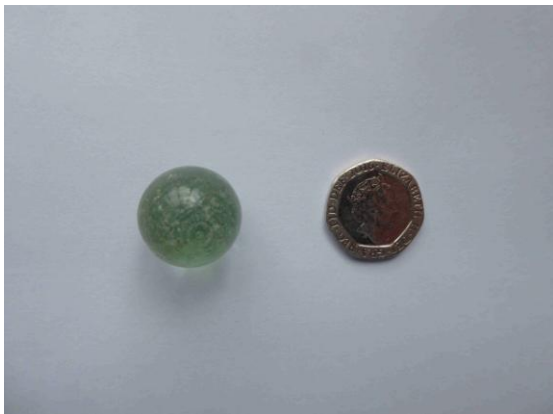
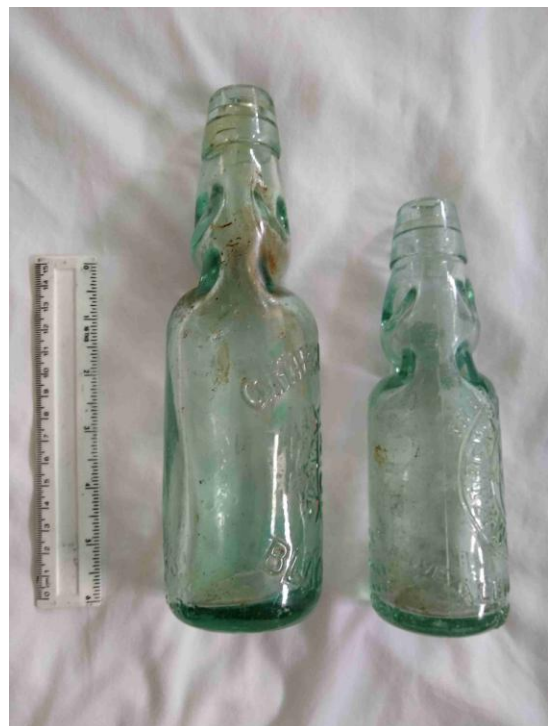
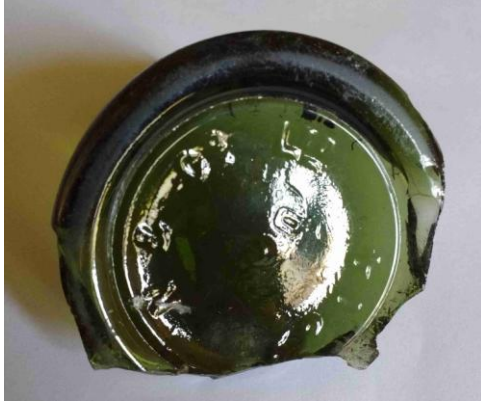
In both trenches any finds came from the soil layer between the plastic and the clay surface. There was abundant broken glass, mainly from bottles. The main identifiable feature being fragments of codd-necked bottles (complete with glass marble) which, having been patented in 1872, must have been deposited after that date. Reconstructed examples are also shown (right).

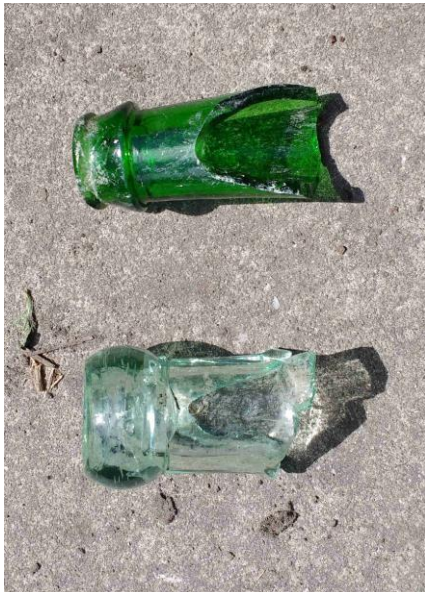
One of the more datable items was the base of a glass bottle. Looking at a number of antique bottle collectors sites the embossed letter "N & Co Ltd" was produced by the Nuttall & Co from around 1900 onwards.

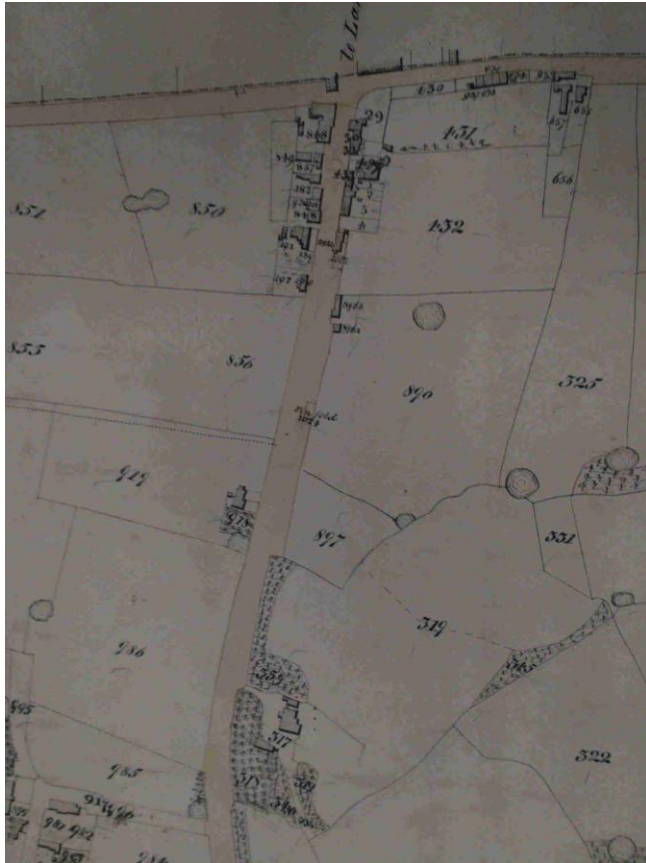
The pinfold appears (without being named) on the OS 6 inch map which was revised in 1910 and published in 1913. The earlier edition; surveyed in 1892 and published in 1895 fails to show the pinfold in the present position. This would tie in with the all of the finds being post 1872. It doesn't appear that the walls were ever "dry-stoned" as the mortared stones in the foundations dispel this idea. The mortar in the visible layers (and possibly the plastic sheeting) was more than likely added in 1985 when a portion of the fold needed renovating.

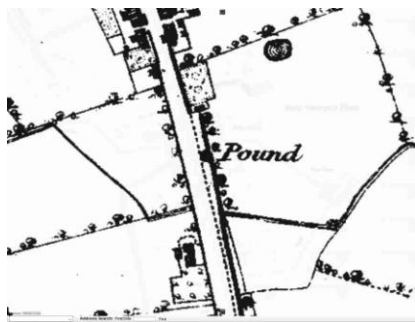
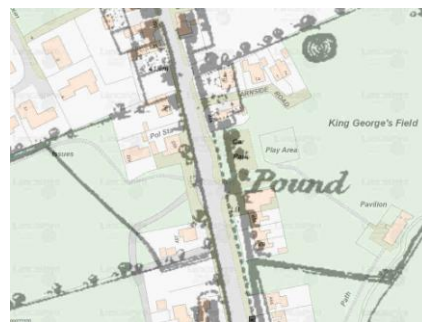
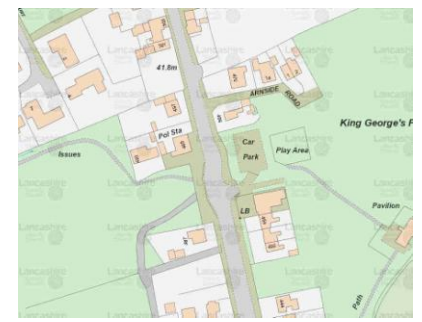
(Images from LCC MARIO - **Maps And Related Information Online**)

The above maps show the 6 inch OS map surveyed in 1844 and published in 1847 together with the modern map and a merged version of these maps. Both of these maps show the pinfold closer to Broughton crossroads - near the entrance to a car park. It is presumed, without having access to any other records, that the original pinfold had to be moved when the road was widened; the obvious place being around 150m to the south.

From this map the pinfold is obviously jutting out into the road. The field to the right was known as pinfold field (896) with the further pinfold field (897) being to the south of this; the present, investigated, pinfold being situated on the southern edge of this field.
