HOLLOWFORTH MILL WOODPLUMPTON

WYRE ARCHAEOLOGY EXCAVATION 2014 – 2018

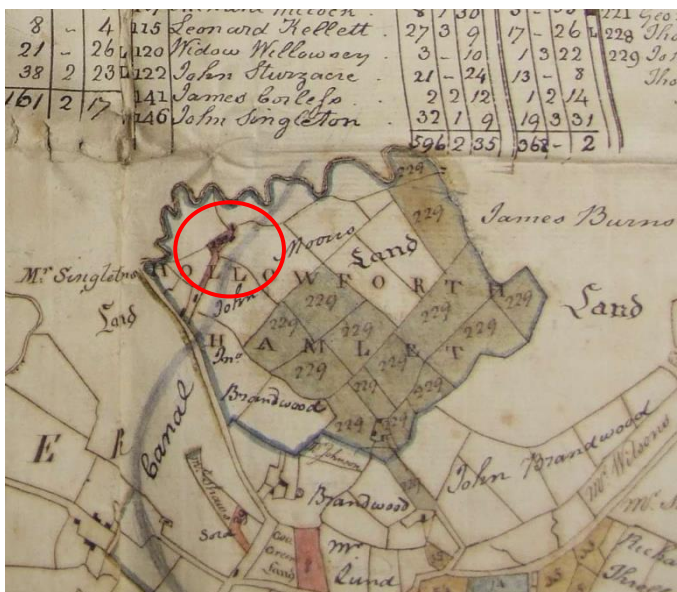
Left: This estate map of 1770 shows the mill just above the 'LL' of 'HOLLOWFORTH'. The blue-grey line running upwards has been drawn in to show the proposed route of the Lancaster Canal.

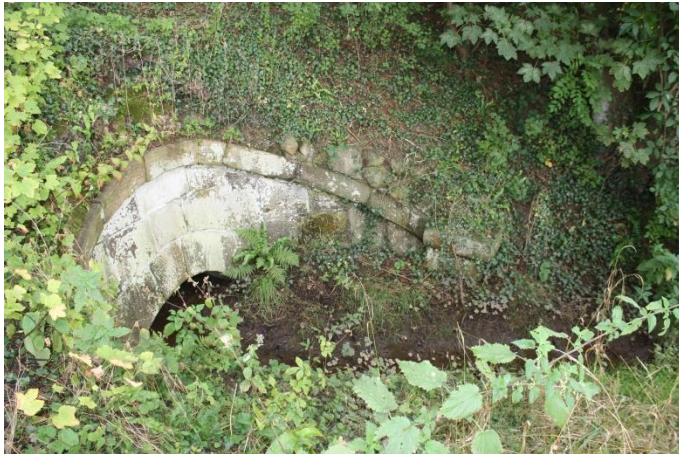
Left: The beautifully constructed base of the aqueduct over the mill race.

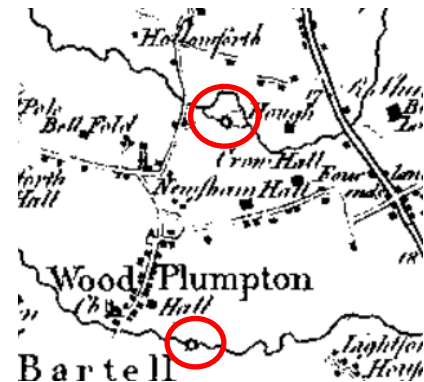
Old maps of the area in Preston's County Archives show several water mills in the area and Yates's map of 1786 clearly shows Hollowforth Mill. (Right: top of map, north of Newsham Hall)

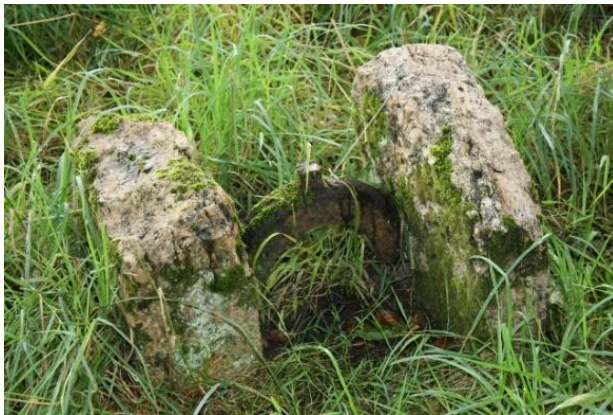
Dave B was able to identify the largest and most significant of these (Left) as the central metal rynd and two blocks of stone from the (upper) running stone of a mill. The running stone is supported by this metal piece fixed to a "mace head" (Below right) topping the main shaft or spindle leading to the driving mechanism of the mill. Of more significance was that the stones were blocks of a particular limestone, originating in an area about 25km SE of

Paris. The requisite number of shaped blocks are assembled into the disc then bound by an iron band and the top surface set in a matrix of plaster of Paris. The completed running stone is known as a 'French Burr'. Their characteristic is that they have a fine surface that produces a very finely ground meal. The

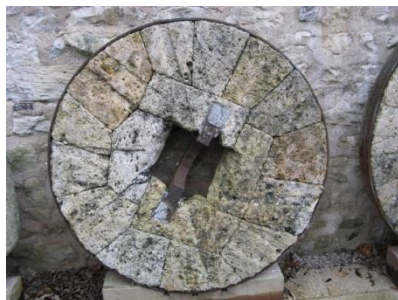
cost of importing the stone either in unassembled pieces or in a finished form and the fine nature of the end product suggests that Hollowforth Mill was, at that time, a profitable venture.

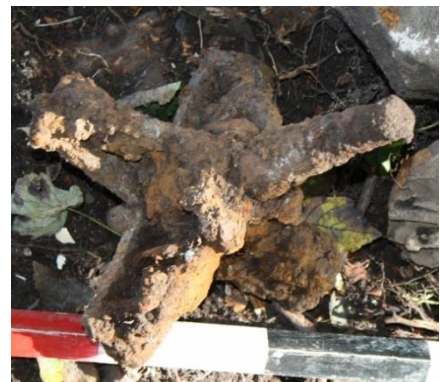
(Left: Complete running stone at Heron Mill, Beetham).

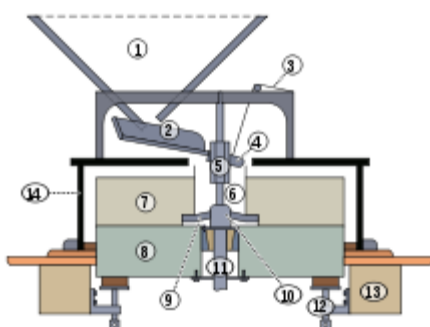
(Left: Wikipedia image of mill mechanism. 1. Hopper 2. Shoe 3. Crook string 4. Shoe handle 5. Damsel 6. Eye 7. Runner stone 8. Bedstone 9. Rind 10. Mace 11. Stone spindle 12. Millstone support 13. Wooden beam 14. Casing)

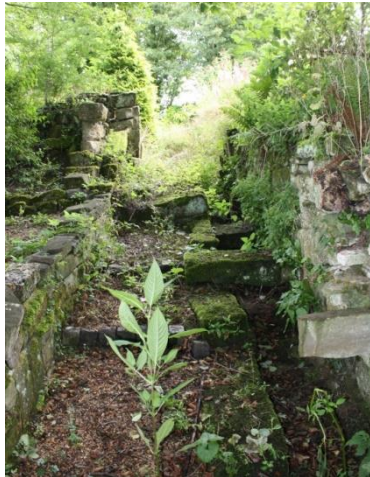
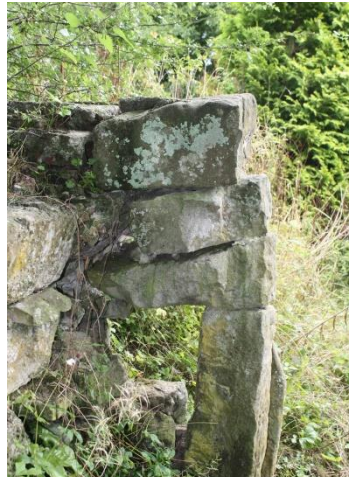
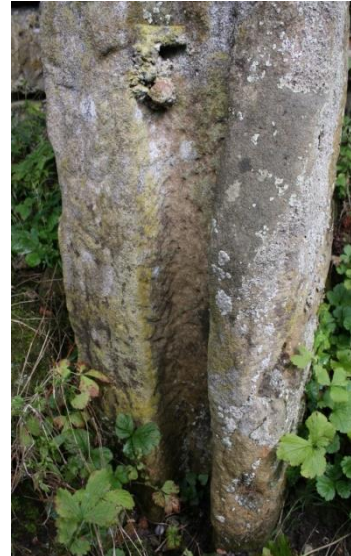
These largely consisted of masonry blocks of regular size, probably 0.3m x 0.15m x 0.15m, assembled to line both sides of the race for a distance of approximately 15m and to a depth of around 1.5m – 2m. Built into these walls on opposite sides of the race were upright masonry posts of about 1.5m height with a longitudinal slot, probably intended to accommodate wooden beams inserted to cut off the flow of

Note well-constructed masonry wall on left of race.

water in order to carry out maintenance of the race and mill machinery (Above). It was interesting to note that the race still contained running water and that 'downstream' of the mill (the tail race) was a large hollow, beyond which the eroded sides of the race suggested flood damage. The race's course continued in the direction of the river which it rejoined close to the modern road bridge. From the profile of the mill race we concluded that the millwheel had been 'undershot' i.e. the water of the race passing under the wheel and turning it counter to the flow.

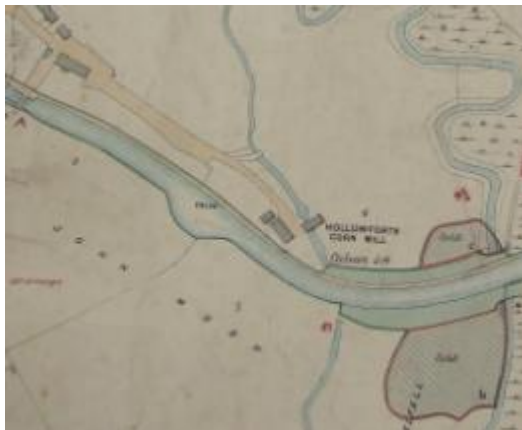
Left: This image (courtesy of Lancashire Archives) shows the area around Hollowforth Mill. The original, base map may have been produced around 1800. At this date the Mill Cottage was two, separate, buildings and the mill itself straddles the mill race.

After consulting a 19th century map it could be seen that the mill buildings at that time straddled the race with a rectangular feature of roughly 15m by 14m on 'our' side of the race. Marking out this rough area, we determined to try to locate the northern extremity of the buildings and began by removing a narrow strip of turf 1m X 3m in a N-S orientation approximately 3m from the supposed NW corner. Immediately below the turf we encountered evidence of destruction: debris consisting of pieces of brick, glass and slate (Right).

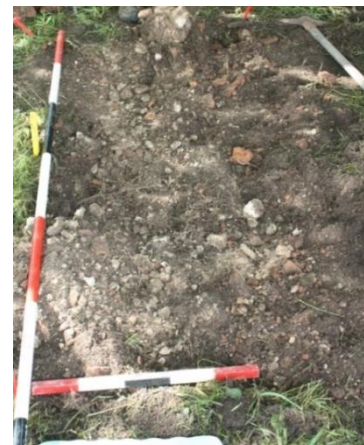
It became apparent as we excavated deeper that we had opened the trench across what appeared to be a ditch lying E-W along the edge of the building. Leaving a narrow 0.5m baulk to the W of this excavation we opened a second 1m x 1m trench again to the W to confirm that the ditch continued to the W. Beyond the postulated western edge of the building was a considerable sub-circular hollow, some 15m x 12m into which the tail race appeared to run. The idea took shape that the ditch might have been a by-pass channel into which the race could be diverted by means of sluices when maintenance of the mill's water wheel was required and that the hollow was the resulting pond formed by this; alternatively, and more likely, the hollow may have been a fishpond, since such features are not unknown to be associated with ancient watermills. This feature is visible on the estate map on P5 and also on the 1840s OS 1:2500 map (Above).

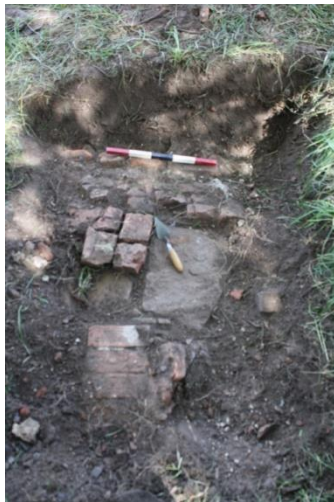
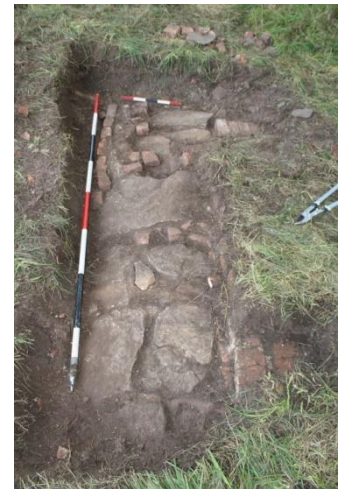
As the dig progressed, these two trenches were backfilled with spoil (our first mistake since we had to reopen them later). The turf was stripped, again revealing destruction debris, in a narrow trench running E-W within the boundary formed by the ditch and starting from the supposed N-E corner of the site. Immediately below the turf was exposed a line of brickwork and stone slabs. The deposition of this led to an initial thought was that this was an external wall that had collapsed outwards into the ditch.

Left: NE Corner with 'collapsed wall'. Trowel points N

Right: View of path looking towards E corner.

Discussion also led to suggestions that the feature may have been a bridge over the ditch, but as more was exposed the view emerged that it was a path, constructed around the external wall of the mill. However later investigation of the ditch showed that our first thoughts were not far off the mark.

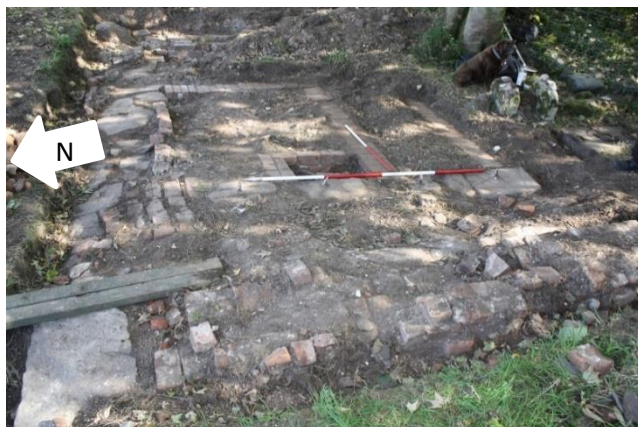
Left: Overburden removed, the outline of the mill building is evident. Possible entrance passage/staircase nearest camera.

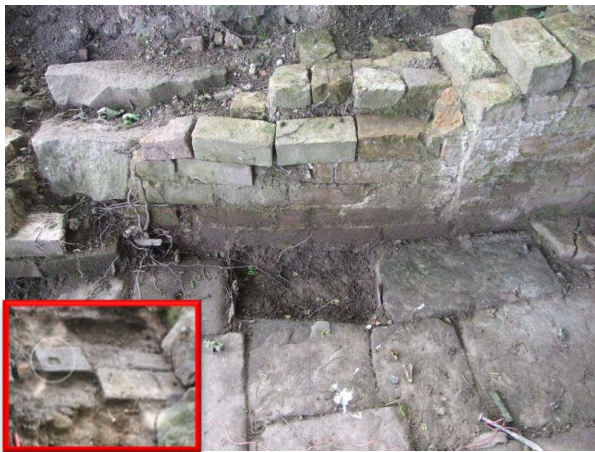
At the eastern end of the building a well-laid stone flag floor was uncovered and the external wall appeared to have a blocked up doorway, since there was an obvious difference in the laying of the bricks and a slight change in alignment (*Left*). Also visible in one of the flags (*inset*) was a shallow rectangular depression approximately 10cm square, the significance of which was not immediately apparent. In the western half of the building a line of four

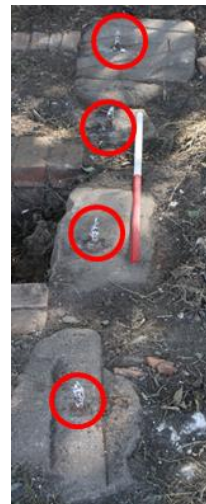
large rectangular blocks featured a 10cm – 12 cm spike in each. It was suggested that these may have been intended to support vertical timbers, perhaps forming the framework of a partition separating off an entrance corridor or staircase (*Right*).

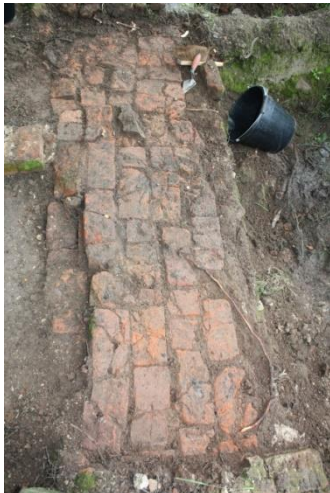
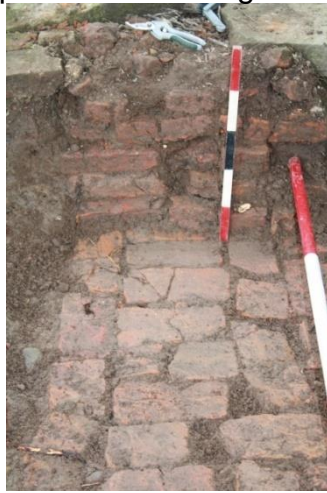
that, although closely laid were not fixed with any mortar. Below this course of bricks was revealed...another course, similarly well-laid. Painstakingly lifted, yet another course was revealed; in fact a total of 7 courses of bricks lay under the surface layer to a depth of over 0.5m (*Left*). The bottom layer was laid directly on natural and the feature appeared to abut the ditch previously exposed. This

brickwork was in such a contrast to some of the external walls which were in places patched and filled with stone and rubble that it provoked much discussion as to its purpose. The eventual consensus was that it may have been built against the

'bypass ditch' to provide a loading bay for carts carrying grain across the fields, perhaps sheltered by a wooden veranda.

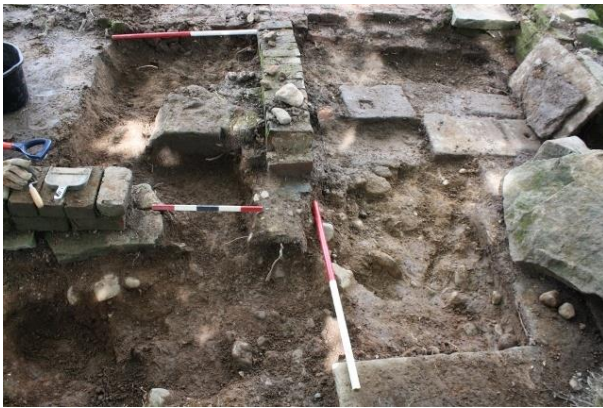
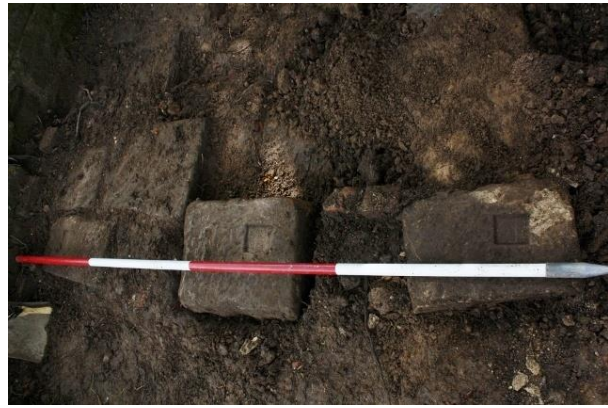
As more of the upstanding, more 'modern' brickwork was removed (*Below left: centre top of picture*) two further rectangular stone blocks of approximately 40 cm and 50cm were revealed, both of which had a 10cm square depression, identical to that described above (*Below right*). It was thought that these represented an earlier phase of the building and possibly represented bases for timber uprights as part of a partition framework.

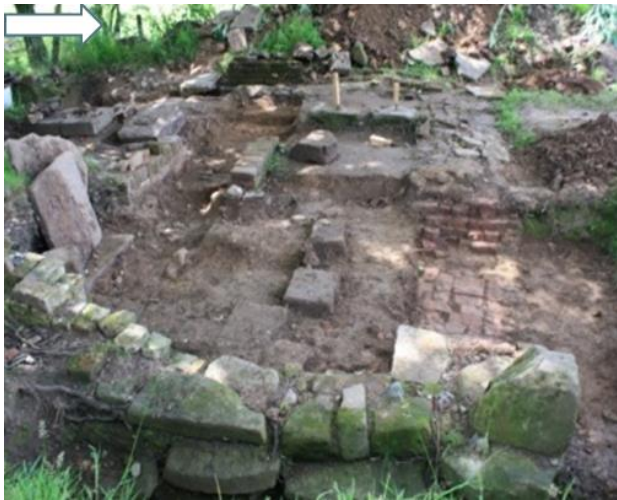
The photo below shows an overview of the site viewed from the eastern boundary with the backfilled ditch to the right, the brickwork feature left of that and the stone blocks centre. Also note the eastern wall closest to camera. The interior is comprised of brick work while the exterior appears to be made up of masonry and re-used millstones (*centre bottom of shot*). On the other side of the fence, however the structure was entirely of masonry, as may be seen in the photograph on page 5 above.

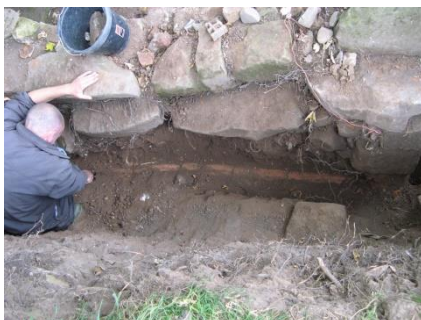
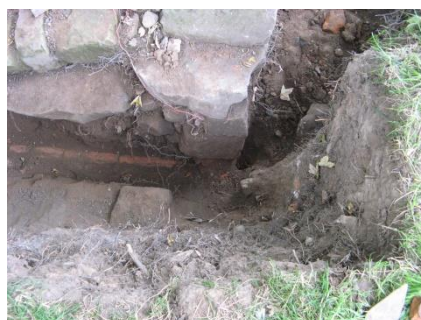
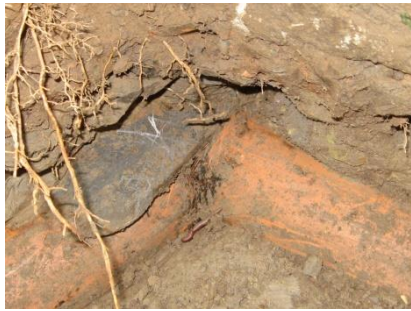
Excavation continued along the extent of the eastern wall and exposed what evidently was a field drain, laid in 30cm sections and running at 90 degrees to the mill race (*Below left*). This was considered to be a later addition and unconnected with the structure but further excavation revealed that at the NE corner where in the above photo a large masonry block is visible, the drain made a 90 degree turn to the west and continued along the now re-excavated ditch (*Left*). At the point where it changed direction it was covered over by a piece of slate.

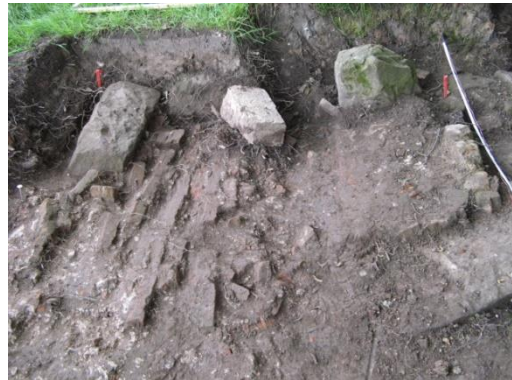
As noted above, the E – W aligned ditch, first uncovered at the beginning of the excavation contained much destruction debris: brick, slate and glass of various thicknesses representing, it was thought, windows of different dates. The eastern end however appeared to be filled with several courses of brick from an apparently ‘slumped wall’

(Right: the wall appears to have collapsed in one piece into the ditch on the left). Below this feature was more destruction debris and one piece of timber (the only one found in the entire excavation) with a nail hammered into it. Altogether this was taken to be further evidence of the sudden and catastrophic end of the mill’s life in the 1920s.

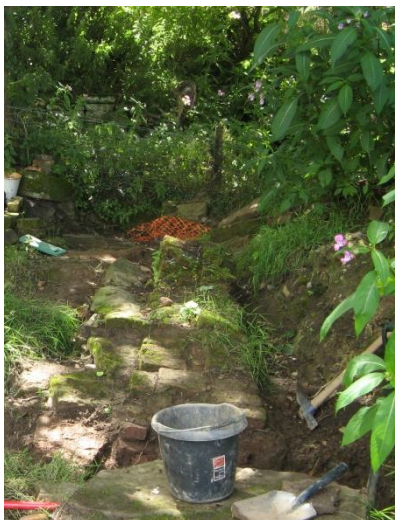
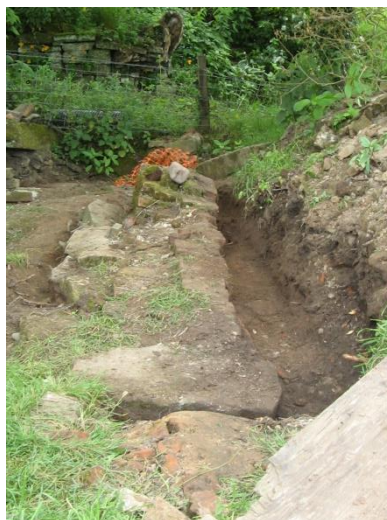
The western wall (*Below*) also showed evidence of collapse. The upstanding remains, again comprised of hand-made brick laid on masonry, had also begun to sag outwards; investigation of this meant that the spoil heap – now nearly 1.5m in height and colonised by Japanese Balsam had to be edged away from the excavation area. As elsewhere, tree roots had penetrated cracks in and between the brickwork and, apart from the damage done to the archaeology, these often had to be chopped away by axe before trowels could be employed.

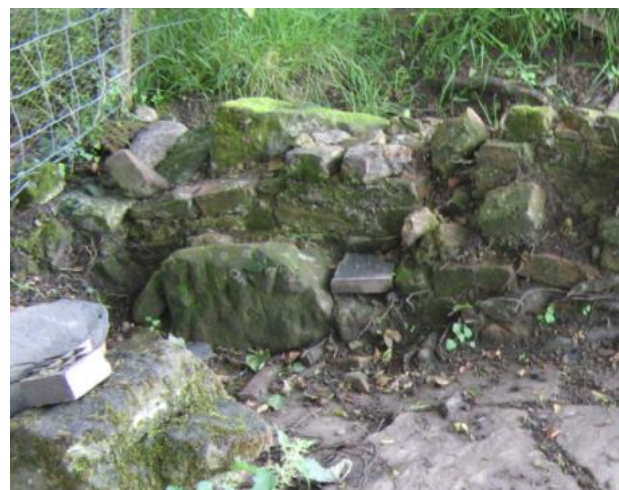
Investigation here indicated that the wall on ‘our side’ of the fence had been laid partly on the natural surface although at the southern end close to the fence there was evidence of a possible foundation trench and levelling with clay and sand. At the boundary under the fence brick work had been bonded with masonry blocks that continued into the adjoining property (*Right*).

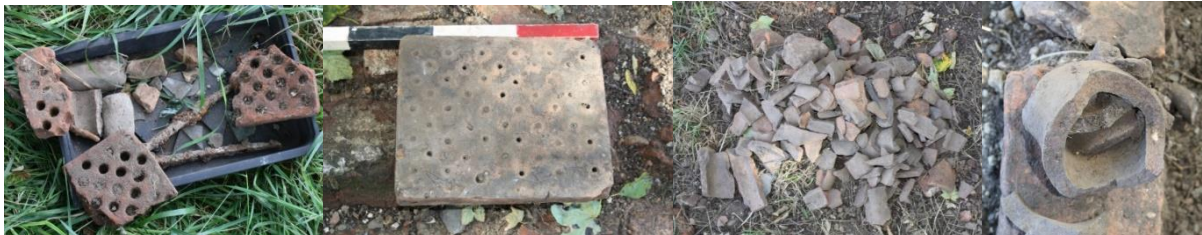
As discussed in the preceding text, many of the 'finds' were associated with the apparent collapse and destruction of the mill sometime in the early 20th C. Apart from a few sherds of glazed ceramic from mugs and plates, some mechanical parts of the mill machinery were recovered as were possible elements of the framework of the machinery. Many pieces of – and some whole – kiln tiles were recovered as were

fragments of clay, maybe furnace pipes and possibly originating from the nearby Threlfall's pipe factory, melded together but no trace of the actual kiln or furnace was uncovered. However a piece of cast iron, embossed with the word 'ATMOS', hinted at a later phase of the mill, since research indicated that this probably referred to a Swedish manufacturer of steam boilers in the mid to late 19th C. It was initially suggested that the water driven machinery may have been converted or supplemented by the installation of a steam engine to drive what may now have become a bone-meal mill, although, since there is no evidence of a change of use, it may have simply been for heating the mill and so its precise purpose remains unknown.

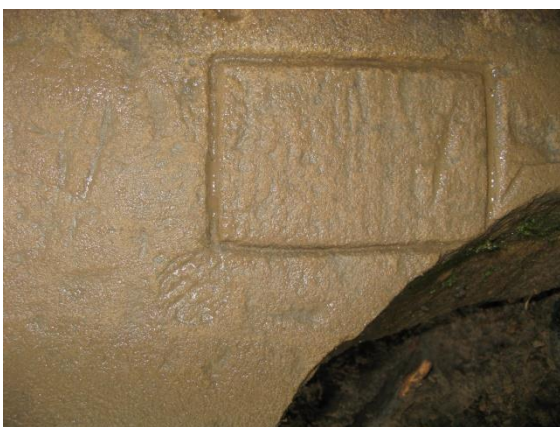
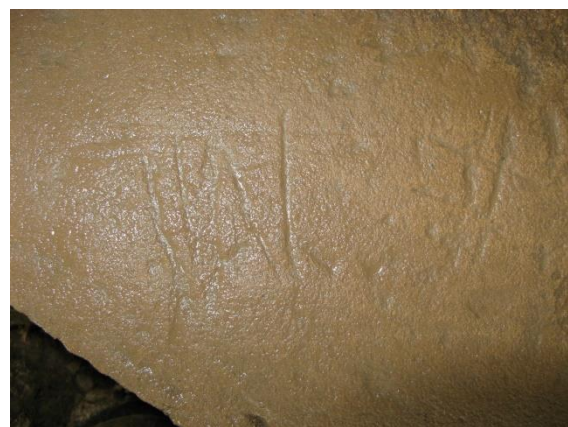
One final 'find' was a large irregular sandstone boulder which on one surface had carved into it a neat rectangle and a small circular image. Intriguingly when turned over there appeared to be the scratched initials 'JW' and other indiscernible lines.

In discussion no explanation could be found for the rectangle and circle but the team wondered if the 'JW' might have been carved by the John Warren (1702) mentioned in Richard Cookson's 'Goosnargh Past and Present' referred to in section 2 above.

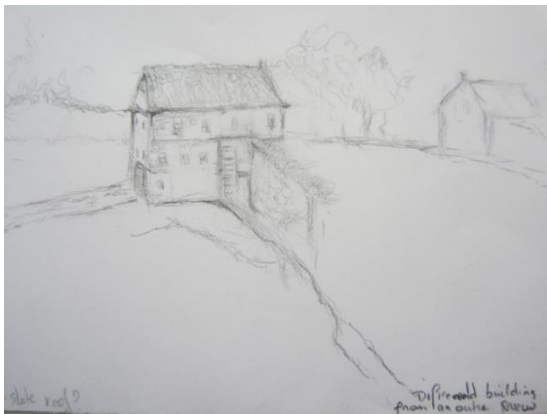
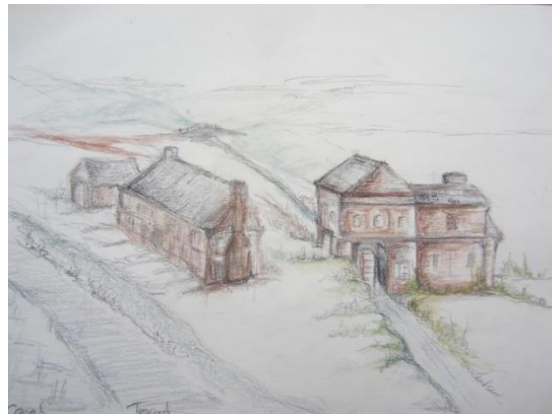
Imagined views of Hollowforth Mill by Ria Teunisse. Left: from East. Right: from West.
